# Floyd Hill Groundwater Planning Cassidy Budge, Gabe Gonzales, Jonah Howe, Katie Kerstiens, Anna Kollmorgen, Nicole Rooney, Austin Toussaint **Colorado School of Mines, SOLVE, Floyd Hill HOA**

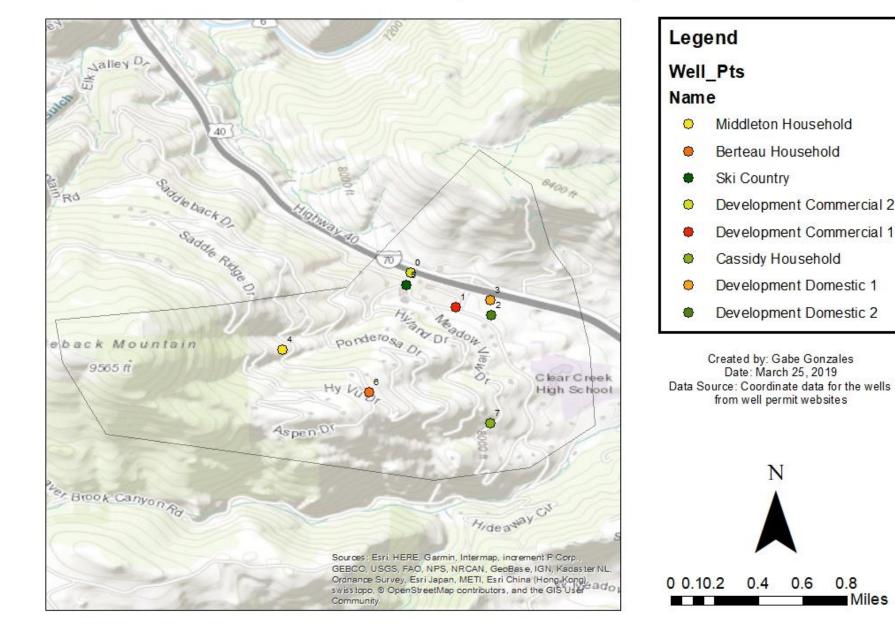
#### Model Boundary Used for AnAqSim

- The aquifer is within fractured bedrock, and to simplify the model it was made as steady state showing changes in elevation.
- Created using assumptions from the Beaver Brook Residence Development (BBRD) hydraulic report and location of tested wells
- Domestic usage rate and geologic parameters were assumed values based on research by USGS

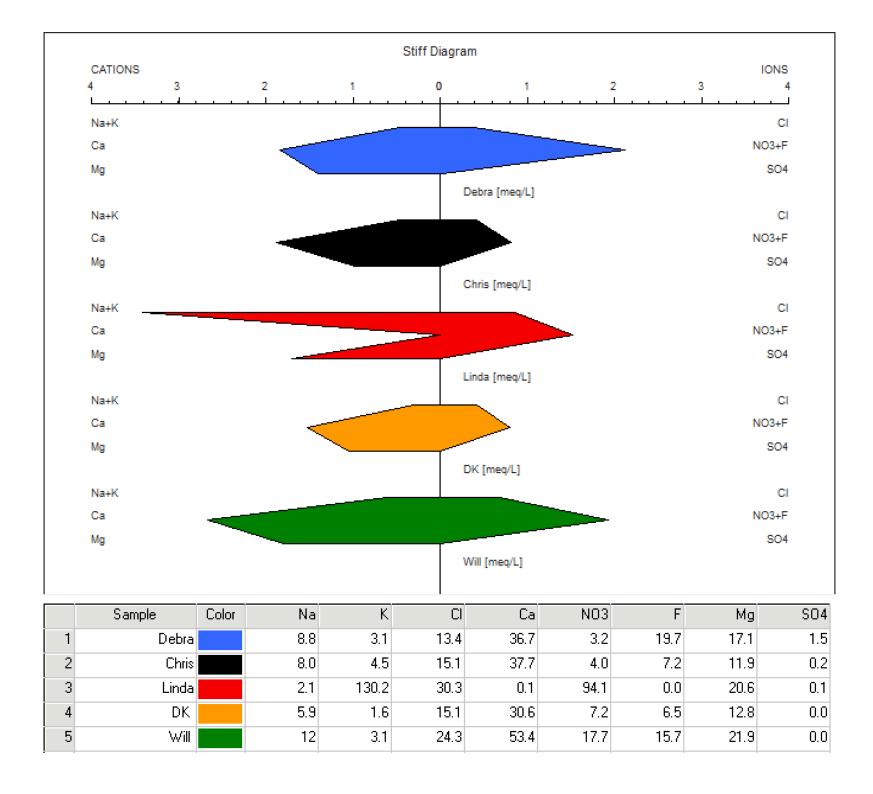
IC and ICP Analysis were conducted on samples collected from the wells of several houses throughout the area. The results were used to help determine the connectivity of water between wells.

ntaminant	Recommended Level (mg/L)	Water Samples Exceeding Recommended Level (mg/L)
luoride*	4.0	None
hloride**	250.0	None
Nitrite*	1.0	476 Aspen ( <b>1.53</b> ) Linda 2: tap ( <b>2.56</b> )
omide***	Trace amounts-0.05	477 Aspen ( <b>0.14</b> ) 476 Aspen ( <b>0.17</b> ) Linda 2: tap ( <b>0.06</b> )
Nitrate*	10.0	Will ( <b>17.73</b> ) Linda ( <b>94.10</b> ) Linda 2: tap ( <b>80.29</b> ) Linda 2: raw ( <b>69.31</b> ) 1300 Ponderosa: tap ( <b>29.64</b> ) 1300 Ponderosa: raw ( <b>33.43</b> ) 476 Aspen ( <b>15.69</b> )
osphate***	0.005-0.05	None
Sulfate**	250.0	None

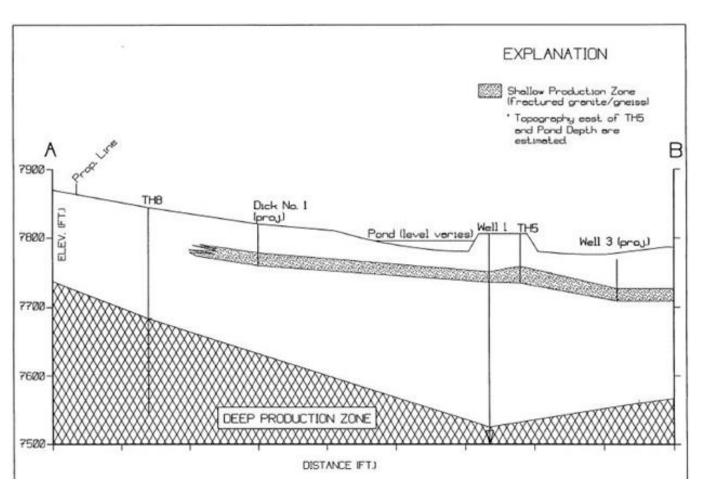
The proposed development is located on a thin layer of Piney Creek Alluvium, on top of that (or interbedded with the alluvium) is a layer of colluvium. Below all these levels, there are igneous and metamorphic rocks containing mostly granite, gneisses, and amphibolite.

The Beaver Brook Hydraulic Report provided a profile of the subsurface around the development area.

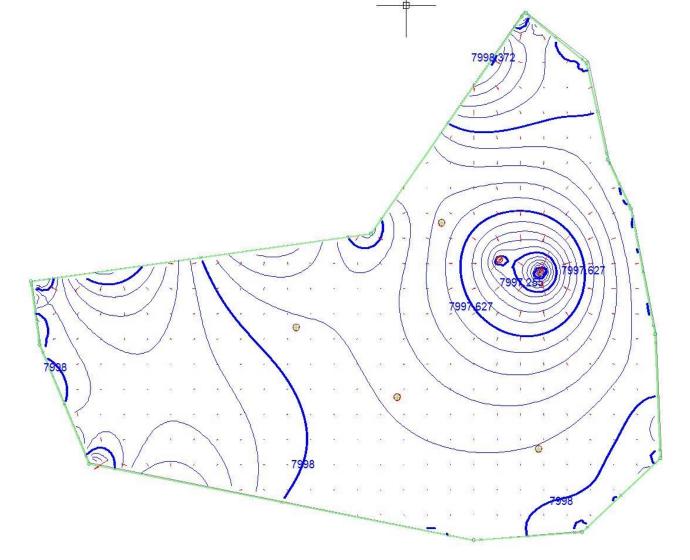
The parameters required to solve the model were all put into AnAqSim, a hydrogeological modeling software, and the model was run according to the data collected. After the AnAqSim model was solved according to the pumping of the six wells, the plot below was created.

The image above is a representation of the whole model. The lower right image is the plot zoomed in.

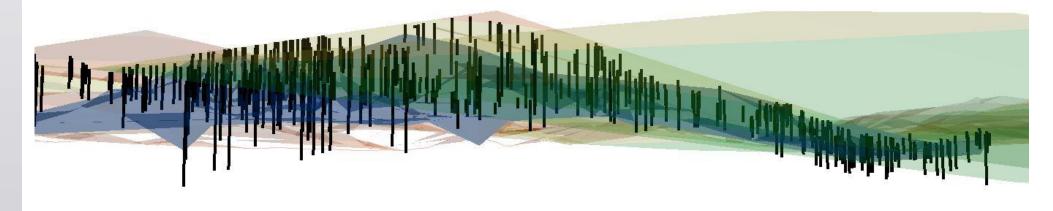
The data to create this map was taken from each individual well permit that was found on the State of Colorado website. The map consists of roughly five-hundred wells.
